CRACKING IN CONCRETE

THE COMMERCIAL FLOORING REPORT
Lew Migliore - President and Owner
LGM Enterprises, LLC - 519 Oxford Street. Dalton, GA 30720
P-(706) 370-5888- F-(706) 270-0482 - Email: lmtcs@optilink.us
Click this link for archives of CFR articles

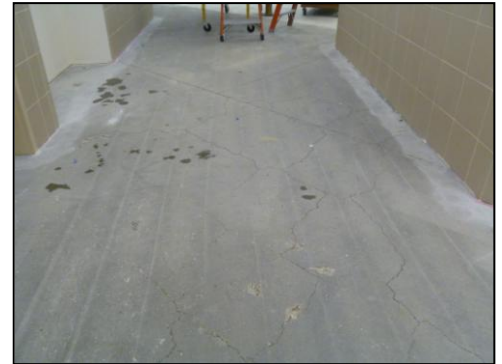
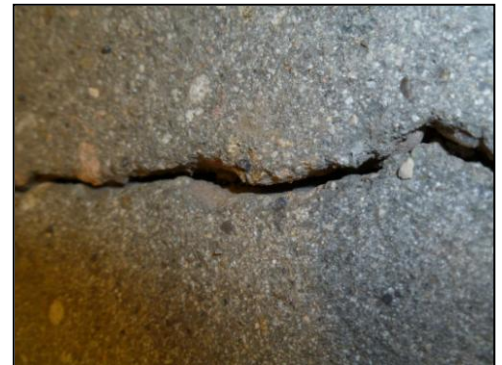
Cracks in the concrete indicate movement of the slab. Any flooring material installed on the slab will be affected by the movement. The greater the slab movement the more flooring problems you'll have. Small cracks may not be mirrored into the flooring material. Larger cracks may suck the material into the space creating a low area which follows the entire crack. Carpet may mask this occurrence more subtly and stone or ceramic floors exhibit it more obviously. For example, several years ago, in a hospital, a radius was shot and drilled into the concrete for the curved reception desk and ceiling feature. The slab drilled into was severely affected by moisture and actually had a volume of water beneath it. As a result the holes drilled for the radius sucked the patch material and the VCT into the depressions that were formed. Slab movement and cracks can cause bubbles, wrinkles and depressions, cracking and splitting of flooring material. Vinyl tiles will react differently than sheet vinyl products but hard surface flooring in general will be more visibly and adversely affected. Broadloom carpet and carpet tile can also be affected but the nature of these products and the patterning they may have, could mask the underlying condition.

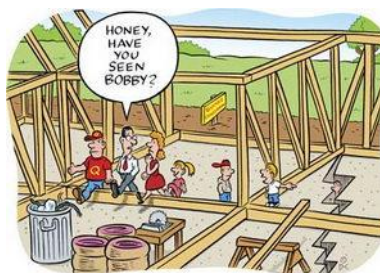
HEAVING IN CONCRETE

The slab can also heave at the perimeter if it curves up or if there is an event on the outside of the space that causes the concrete to move. You can see in the accompanying photos that the ceramic tile has lifted at the perimeter of the rooms. The affected tiles can't just be removed and replaced. The cause of the substrate lifting has to be resolved and repaired first and then the flooring material replaced. None of these activities are easy or inexpensive. Many of the causes for concrete issues, including cracking, being experienced today are the result of construction schedules moving at light speed and the "dam the torpedoes, full speed ahead mentality" that seemingly thinks it can defy the laws of physics. The cost to correct flooring failures as a result of this type of thinking far outweighs the fast paced construction schedule. Why is it that you don't have time to do it right, or the budget, but find the time and money to fix afterwards? Does this make sense? Given the "Green Mentality" permeating everyone's thinking of not wasting resources, this flies in the face of conserving. You couldn't plan to waste resources any better. Remember what I've said before about green flooring issues, "Get it in the door and keep it on the floor." That's not going to happen when you try to defy the odds of flooring failures occurring and it's going to get worse.

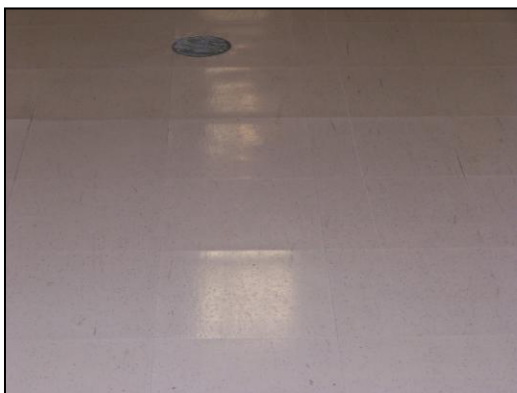
The installation of over 8,500 feet of vinyl tile curling at the edges in a two and a half year old church surfaced one and a half years after the installation. The church also had other flooring materials that were unaffected; tile flooring installed in the front areas, carpet glued directly to the substrate in two inner hallways and in the sanctuary aisles and engineered wood installed in the sanctuary under the pews. None of the flooring materials were showing any type of failure except the vinyl tiles. The first thought, always, is that the flooring material is failing and 1. Must be defective or 2. The installation is the problem. As is often the case, neither was the cause. By lifting up loose tiles it could be easily seen and felt that the substrate beneath them was damp. Because the tiles are non – permeable material, they trap the moisture beneath them causing the adhesive and

adhesion to fail and thus allow the tiles to lift or curl. Again, as always, the law of physics is at work; that is, for every

action there is an equal and opposite reaction. The moisture in the substrate compromises the adhesive, this loosens the tiles, the moisture, in the form of a vapor, has to escape and does so along the perimeter of the tiles causing them to lift and curl because they are no longer adhered along the edges. So certainly when first seeing this condition it's going to seem like the tiles are defective or the installation is failing.

Where do you look for the cause? In this case we had to look outside. Moisture had to be influencing the concrete substrate and it was by intrusion. The grading on the outside of the building was not pitched completely or properly away from the building envelope. The down spouts for the gutters were right next to the building foundation which was slab on grade and did not drain the runoff water from rain far enough away from the building. In addition, the splash blocks which the down spouts emptied onto, were actually pitched back towards the foundation. So when it rains the water rushing down the gutters hits the splash blocks and, though they are facing in the right direction but because they are not properly elevated, the water is directed forward but also overflows backwards towards the slab - so obvious as to be oblivious. This was the underlying cause of the vinyl flooring installation failure. Before the flooring failure can be addressed the drainage issue has to be corrected. Why didn't the other flooring materials fail? The carpet glued directly to the substrate is permeable and moisture vapor emission can pass through it but eventually, the adhesive may be compromised by the alkalinity coming with the moisture from the concrete and a failure could result. The wood flooring and the ceramic tile are further from the edge of the foundation and moisture may not have migrated that far under the slab. The mortar bed for the tile is permeable enough that moisture vapor will pass through it and, being a cementitious bond, there is no adhesive to fail. All this said; when a flooring failure similar to this occurs on grade make sure you look outside the building envelope where you're likely to find the cause.

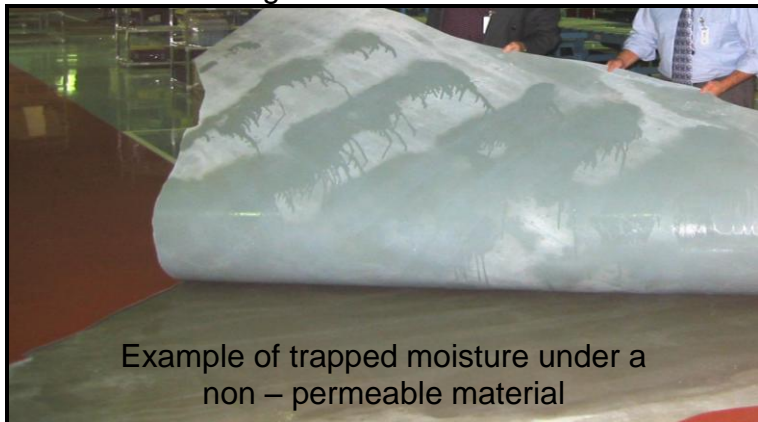
Example of trapped moisture under a non – permeable material
